Erratum for “Unpacking Tornado Disasters: Illustrating Southeastern US Tornado Mobile and Manufactured Housing Problem Using March 3, 2019 Beauregard-Smith Station, Alabama, Tornado Event” by Stephen M. Strader, David B. Roueche, and Brett M. Davis

Unpacking Tornado Disasters: Illustrating Southeastern US Tornado Mobile and Manufactured Housing Problem Using March 3, 2019 Beauregard-Smith Station, Alabama, Tornado Event

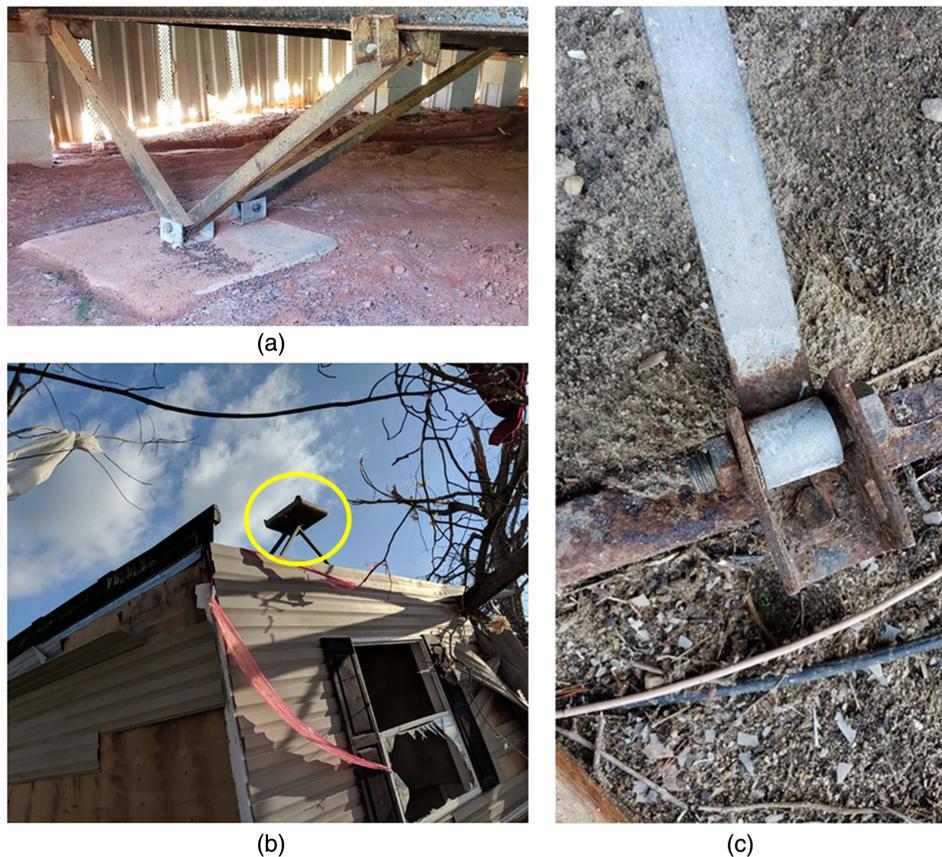
Fig. 7. Common anchorage problems encountered in the Beauregard, Alabama, tornado included (a and b) frequent use of pan-style alternative anchorage systems, which provide no uplift resistance; and (c) corrosion of diagonal ties and ground anchors. The circle in plot (b) illustrates an overturned MH with a pan anchorage system. (Images by David B. Roueche and Brett M. Davis.)

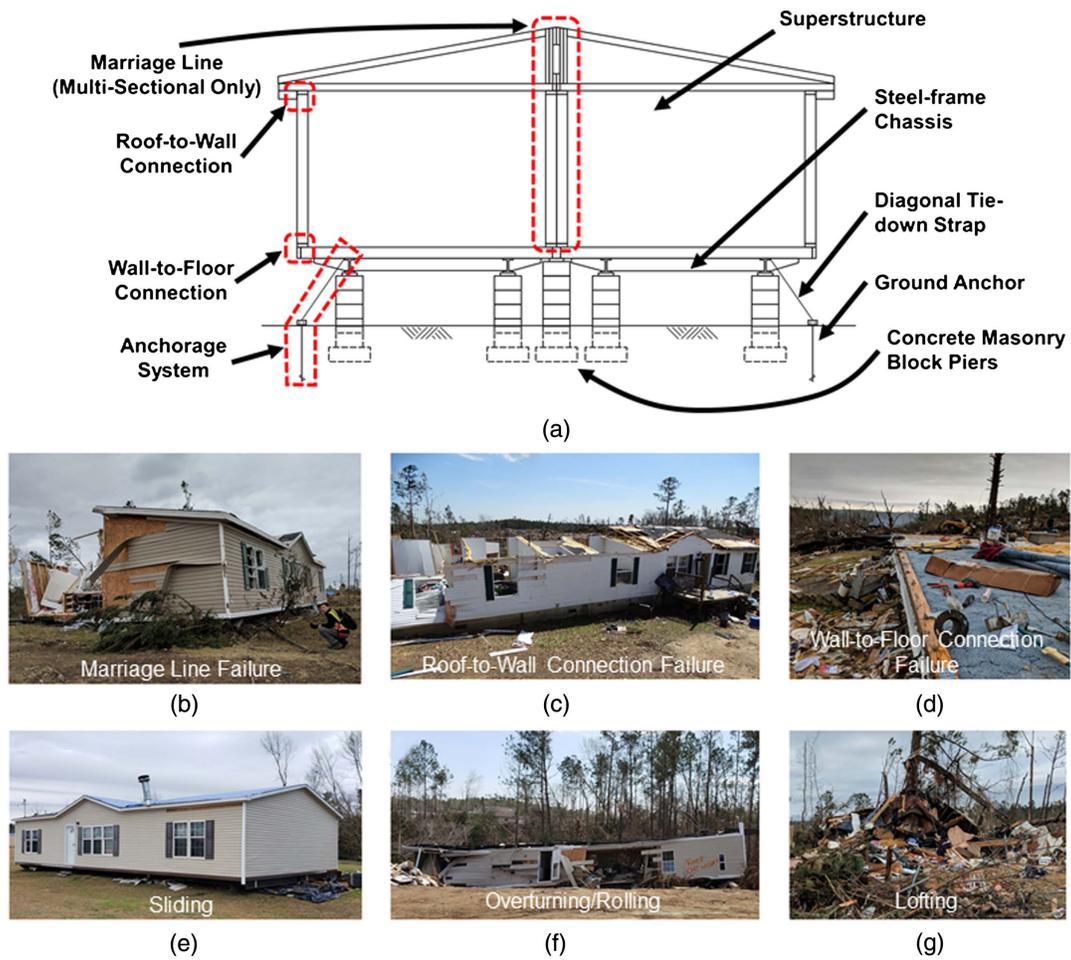
Fig. 8. (a) DWMH construction diagram with critical components and their locations labeled. Thick dashed lines highlight those areas where common failure mechanisms occur during tornado events and relate to the damage survey photos [(b)–(g)]. Failure mechanisms in MHs included (b) separation at the marriage line in DWMH; (c) roof-to-wall connection failures; (d) wall-to-floor connection failures; and (e–g) failures of the anchorage system, specifically (e) sliding; (f) overturning/rolling; and (g) lofting. (Images by David B. Roueche and Brett M. Davis.)

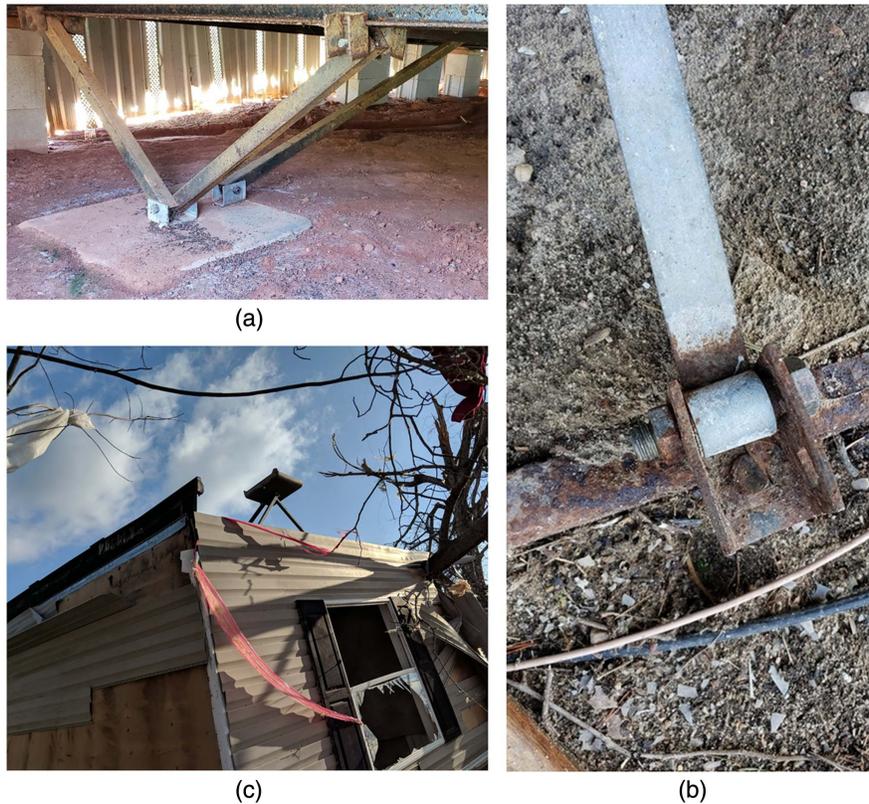
The *key failure mechanism* that led to the destruction of several PHs and many MHs was *the lack of any positive anchorage to the ground*. Many PHs were simply resting on unreinforced masonry stem walls that offered no resistance to the uplift forces induced by a tornado, a weakness recognized in past studies also (e.g., Marshall 1993; Prevatt et al. 2012a). Where PHs were constructed on concrete slabs, with anchor bolts to the slab through the sill plates, at a

Fig. 7. Common anchorage problems encountered in the Beauregard, Alabama, tornado included (a and b) frequent use of pan-style alternative anchorage systems, which provide no uplift resistance; and (c) corrosion of diagonal ties and ground anchors. The plot (b) illustrates an overturned MH with a pan anchorage system. (Images by David B. Roueche and Brett M. Davis.)

- The fatality rate in the Bearegard-Smith Station, Alabama, tornado was seven times greater than that of the 2011 Joplin, Missouri, EF5 tornado. This greater fatality rate is at least in part attributed to the much larger percentage of MHs in the Bearegard-Smith Station, Alabama, tornado damage path compared to that of the Joplin, Missouri, tornado.
- All homes (MHs and PHs) where fatalities occurred and anchorage systems could be ascertained either entirely lacked positive anchorage to resist wind uplift forces beyond the self-weight of the home, or in the case of MHs with tie-down straps and ground anchors, had what minimal positive anchorage was present compromised by corrosion and other installation defects.

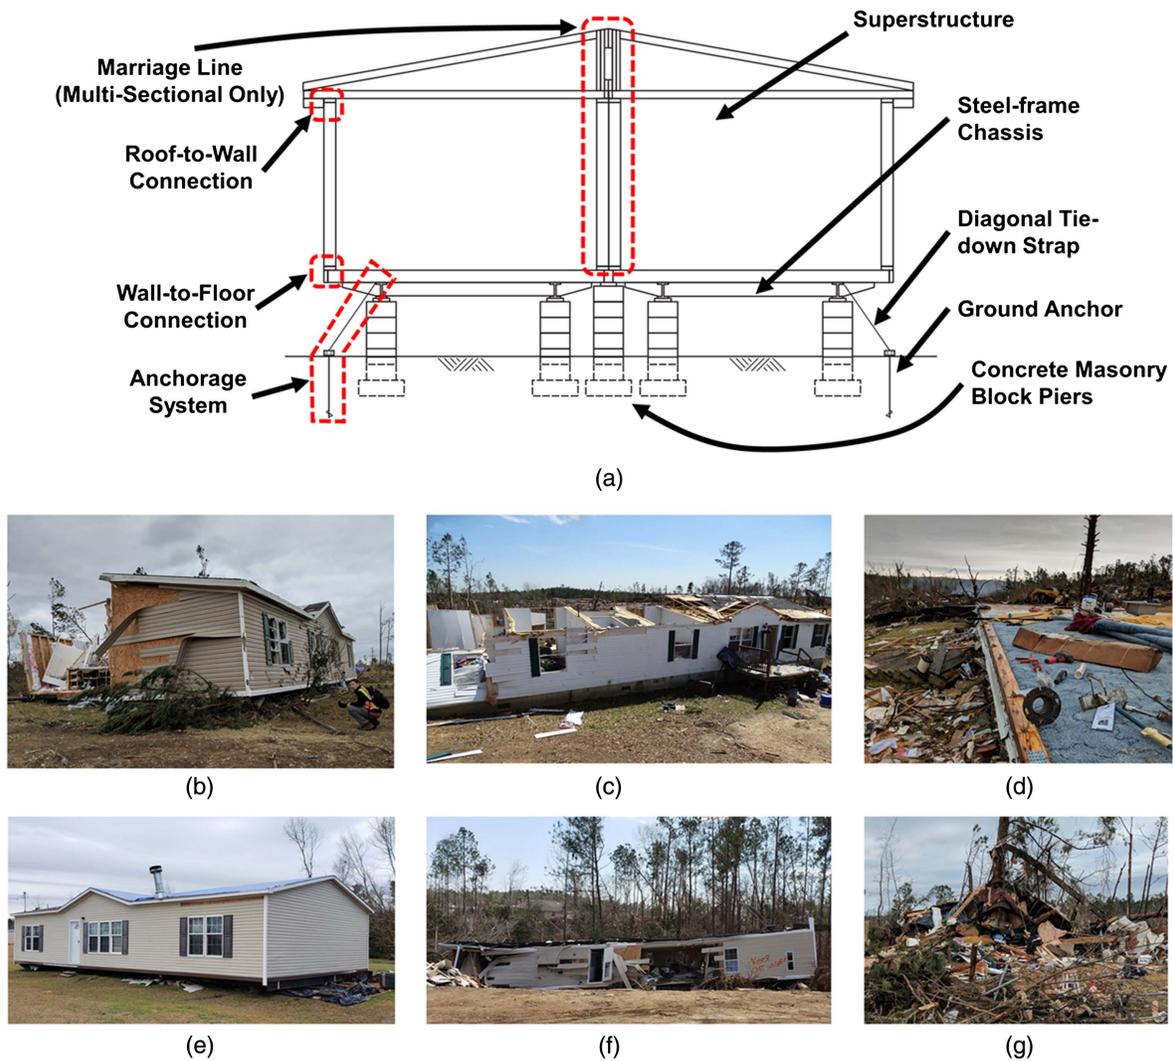
A considerable trend in the MH failures was the overall lack of an optimum damage progression. While damage generally initiated with loss of roof cover and cladding elements, very rarely was the loss of roof sheathing or roof structure observed with the anchorage system intact. The four primary mechanisms of structural failures observed in MHs consisted of the following: (1) separation at the marriage line (DWMHs only), (2) roof-to-wall connections, (3) wall-to-floor connections, and (4) failure of the anchorage system, resulting in either sliding, overturning, or lofting (Fig. 8). Of these potential mechanisms, the anchorage system was nearly universally the first element of the structural load path to fail during the tornado, compromising the entire structure and the safety of the occupants. This lack of safe failures in both SWMHs and DWMHs relative to PHs is exemplified in Fig. 6. Specifically, 12 of the 20

Fig. 8. (a) DWMH construction diagram with critical components and their locations labeled. Thick dashed lines highlight those areas where common failure mechanisms occur during tornado events and relate to the damage survey photos [(b)–(g)]. Failure mechanisms in MHs included (b) separation at the marriage line in DWMH; (c) roof-to-wall connection failures; (d) wall-to-floor connection failures; and (e and f) failures of the anchorage system, specifically (e) sliding; (f) overturning/rolling; and (g) lofting. (Images by David B. Roueche and Brett M. Davis.)
