Erratum for “Unpacking Tornado Disasters: Illustrating Southeastern US Tornado Mobile and Manufactured Housing Problem Using March 3, 2019 Beauregard-Smith Station, Alabama, Tornado Event” by Stephen M. Strader, David B. Roueche, and Brett M. Davis

Unpacking Tornado Disasters: Illustrating Southeastern US Tornado Mobile and Manufactured Housing Problem Using March 3, 2019 Beauregard-Smith Station, Alabama, Tornado Event

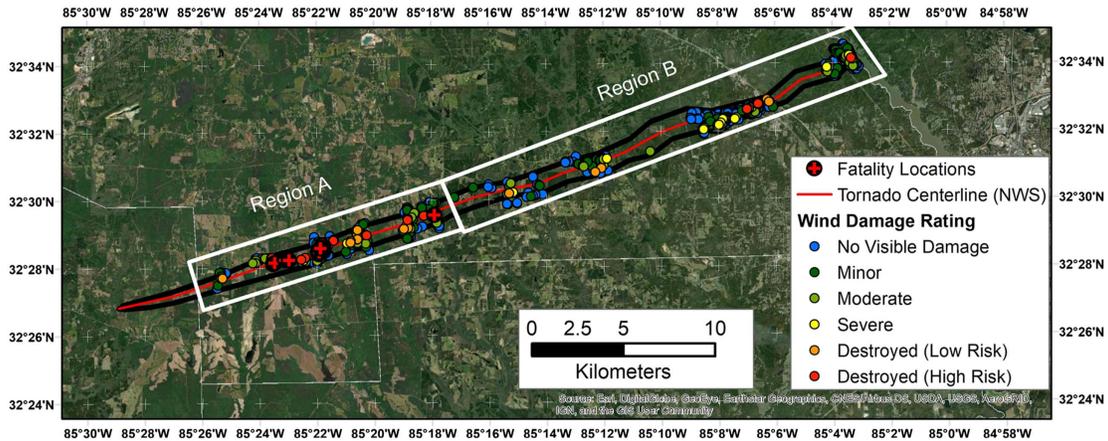
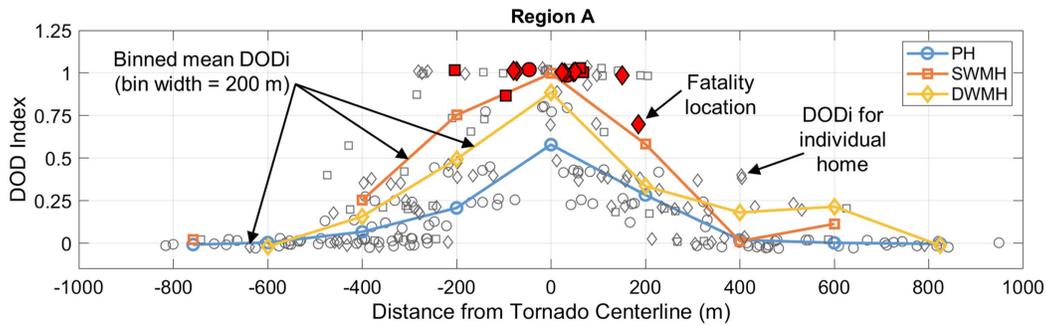
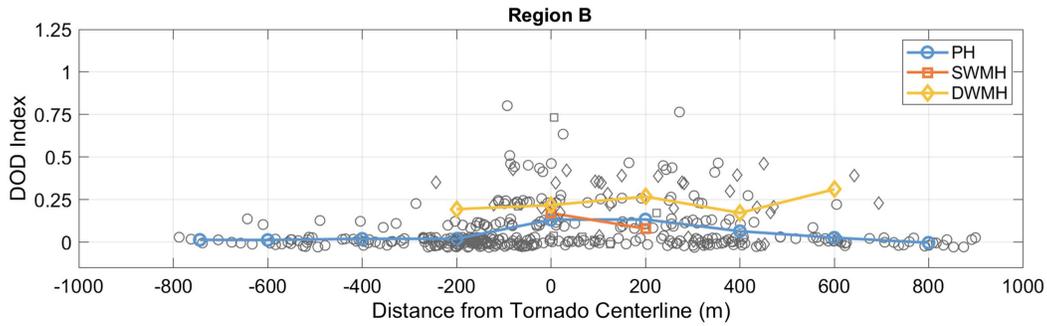
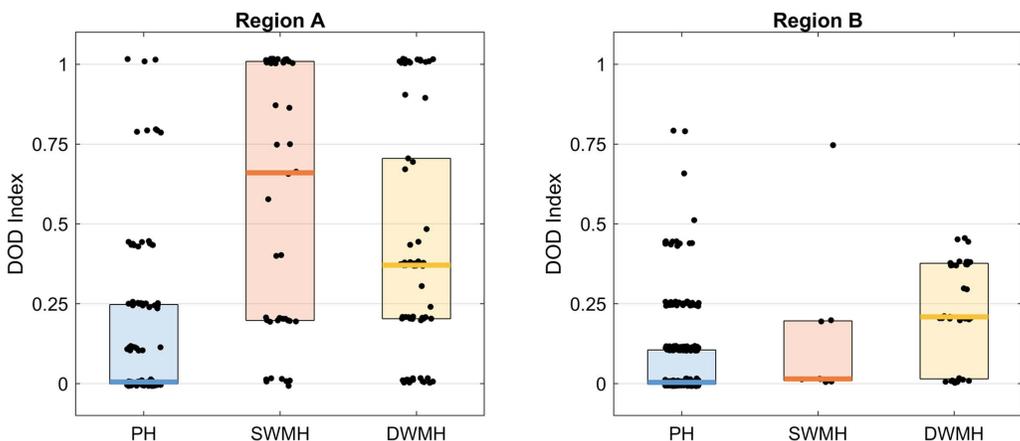
Fig. 5. Wind damage assessments for all structures in the tornado path: (a) spatial overview of entire tornado path using categorical damage ratings (base map by “World Imagery” Esri, Maxar, Earthstar Geographics, CNES/Airbus DS, USDA FSA, USGS, AeroGRID, IGN, IGP, and the GIS User Community); and (b and c) DODi for SWMHs, DWMHs, and PHs in Regions A and B of the tornado with respect to the center of the tornado. Lines indicate average DODi over 200-m-wide bins. Negative distances indicate homes located on the north side of the centerline. Jitter has been added to the y-coordinates to facilitate better visualization. Filled markers in (b) and (c) indicate fatality locations. (d) Box plot indicating the median, 25th, and 75th percentiles of DODi for all PHs, SWMHs, and DWMHs in Regions A and B.

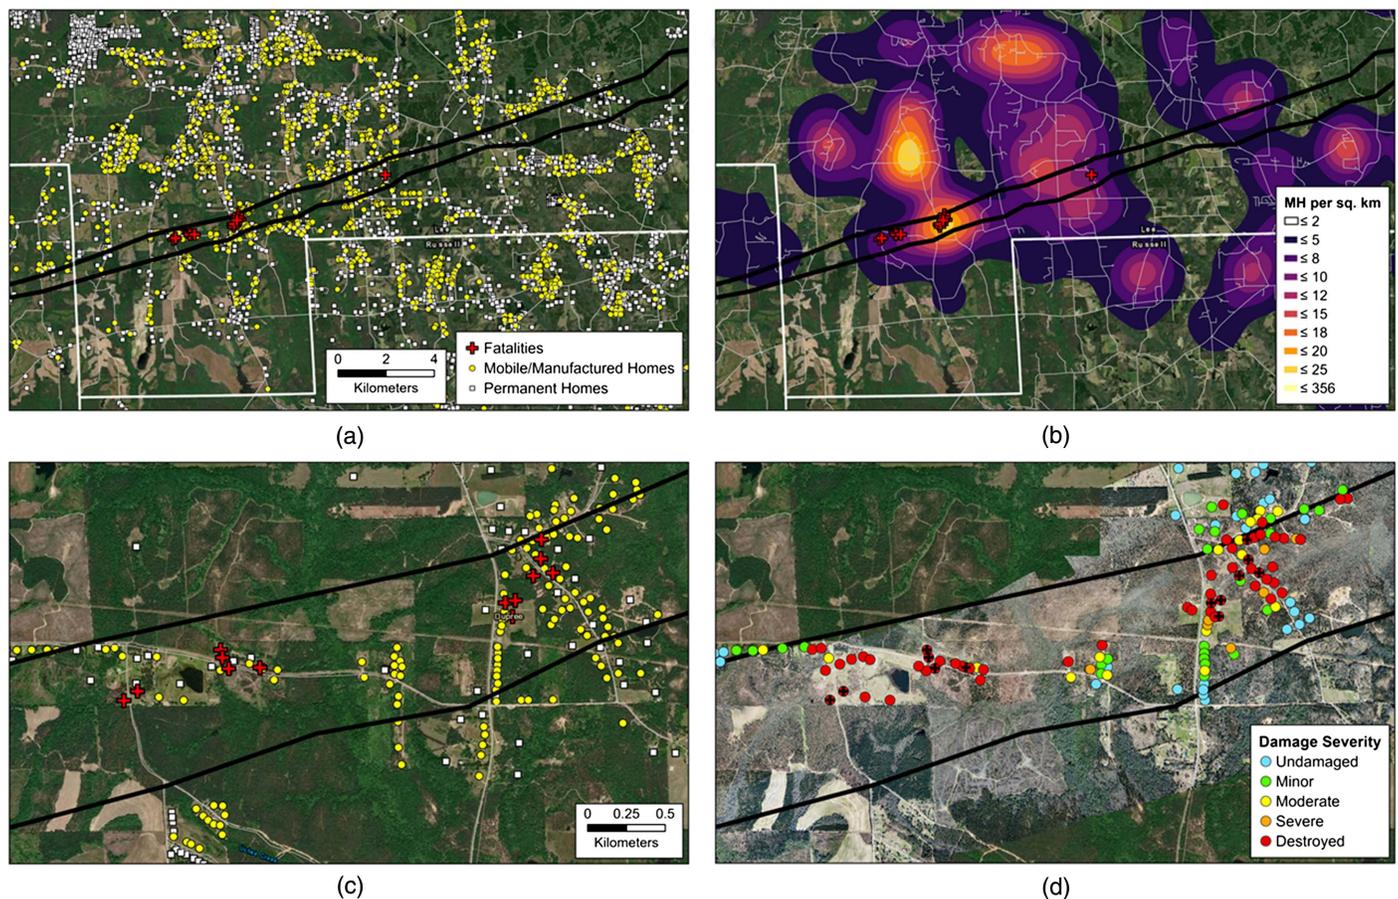
Fig. 4. Beauregard-Smith Station, Alabama, surveyed NWS tornado damage path (outlined polygon): (a) MH, PH, and fatality locations (cross); (b) MH density (MHs per km²); (c) zoomed-in area of Route 36 to Route 38 in the Lee County, Alabama, region where most fatalities occurred; and (d) damage severity based on the postevent damage assessment.

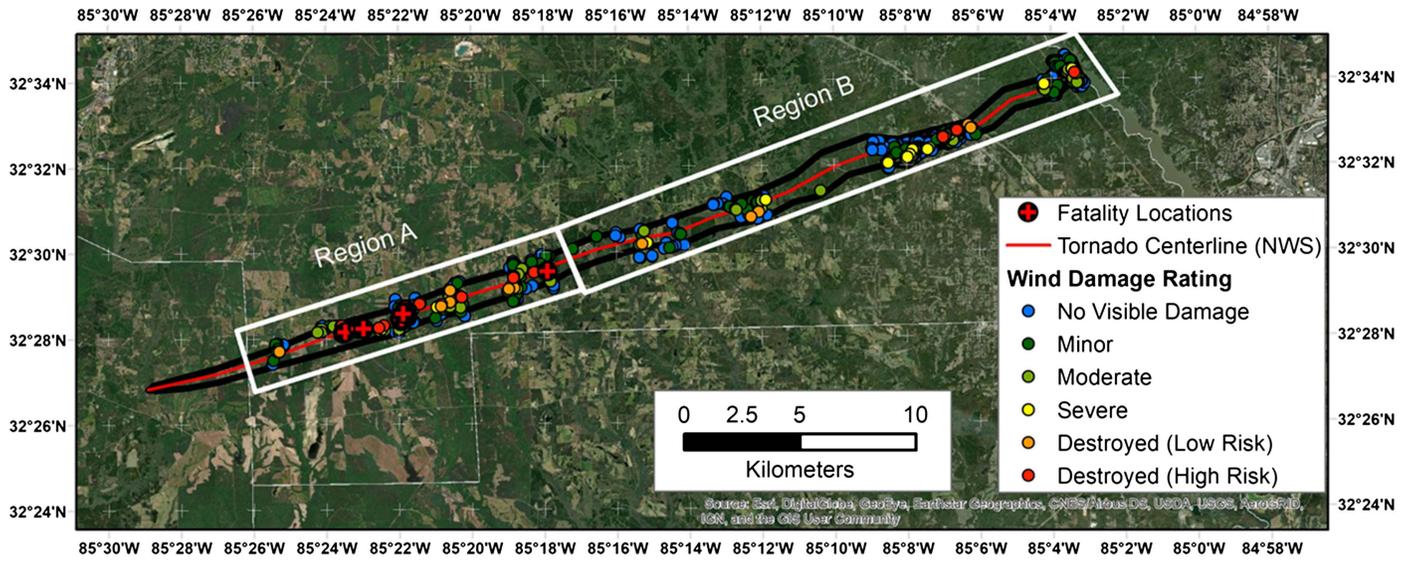
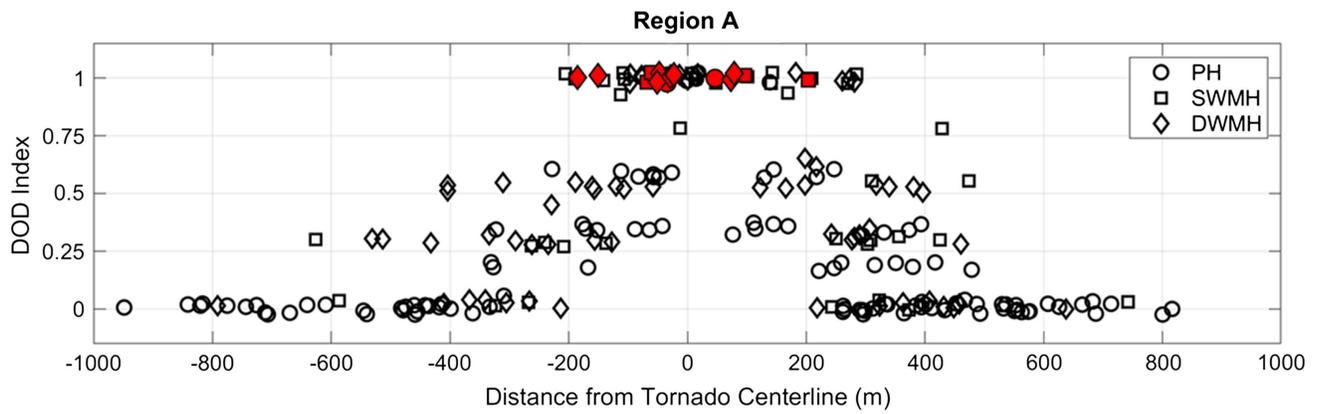
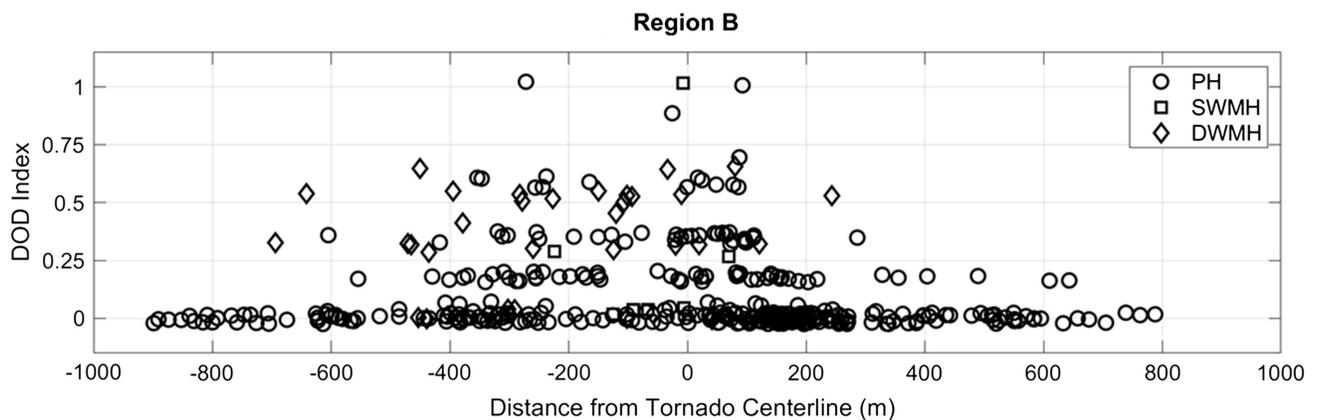
Wind performance for all buildings was primarily a function of the distance along the length of the tornado damage path and the distance from the centerline of the tornado [as estimated by the NWS (NWS and BMX 2019) damage path, approximate center of heaviest damage, and building typology (Fig. 5)]. Observations indicated that the robustness of the foundation or anchorage system played a significant role in determining a building's wind performance and/or damage severity within the tornado path. Although building orientation was a factor for all building types, the damage survey indicated that it was most important for MHs (Roueché et al. 2019). Significant damage to nonresidential structures was limited to older commercial and religious facilities with light-frame wood or unreinforced masonry structural systems. The most severe damage to nonresidential buildings was experienced by a small, unreinforced masonry church located near the beginning of the tornado path that was destroyed. No nonresidential structures were located within the path of the tornado when its intensity was the highest, near Highway 51 and Lee Road 38. Nonresidential structures were more common in and around Smith's Station, where the intensity of the tornado was reduced, and damage was very minor outside of a car dealership and restaurant. Both the car dealership and restaurant were older (pre-2000), light-frame buildings that experienced loss of the structural roof system. The only school affected within the

Fig. 5. Wind damage assessments for all structures in the tornado path: (a) spatial overview of entire tornado path using categorical damage ratings (base map by “World Imagery” Esri, Maxar, Earthstar Geographics, CNES/Airbus DS, USDA FSA, USGS, AeroGrid, IGN, IGP, and the GIS User Community); (b) and (c) DODi for SWMHs, DWMHs, and PHs in Regions A and B of the tornado with respect to the center of the tornado. Lines indicate average DODi over 200-m-wide bins. Negative distances indicate homes located on the north side of the centerline. Jitter has been added to the y-coordinates to facilitate better visualization. Filled markers in (b) and (c) indicate fatality locations. (d) Box plot indicating the median, 25th, and 75th percentiles of DODi for all PHs, SWMHs, and DWMHs in Regions A and B.

Of the 380 structures affected by the tornado, 328 were single-family homes (DIs 2, 3, and 4 in the EF scale). To better assess tornado impact severity to these structures, the tornado damage path was split into two primary geographic components, Region A and Region B (Fig. 5). The tornado path was split into these two regions based on damage severity and potential changes in tornado intensity as discussed previously. Damage was more severe within the first 20 km (12 mi) of the tornado path (designated Region A) than in the remainder of the path (designated Region B). Within Region A, complete structural failure in both PHs and MHs was most common within an approximately 250-m buffer on each side of the tornado centerline. Within this region, and in general across the entire tornado width in Region A, SWMHs sustained the highest damage on average, with PHs sustaining the lowest damage on average [Figs. 5(b and d)]. In Region B, extending from the edge of Region A to the Alabama-Georgia border, complete

structural failure rarely occurred, despite similar building typologies, indicating the reduction in tornado intensity [Figs. 5(c and d)]. In both regions, SWMHs were the most likely to exhibit complete or catastrophic failure (Fig. 6), with 54% in Region A and 13% in Region B exhibiting damage with a high risk to life safety. This corresponded to 22 of the 41 damaged SWMHs in Region A, and one of the eight damaged in Region B, that experienced DOD6 or higher (i.e., the unit rolled, lofted, and/or experienced the destruction of the roof and all walls). DWMHs and PHs demonstrated better performance, with 29% (20 out of 70) of DWMHs and 16% (8 out of 50) of PHs with failures deemed high risk to life safety in Region A, and 0% (0 out of 35) and 2% (2 out of 124), respectively, in Region B. The two high-risk PH failures in Region B occurred in a section of poorly constructed, low-income homes in Smith Station.

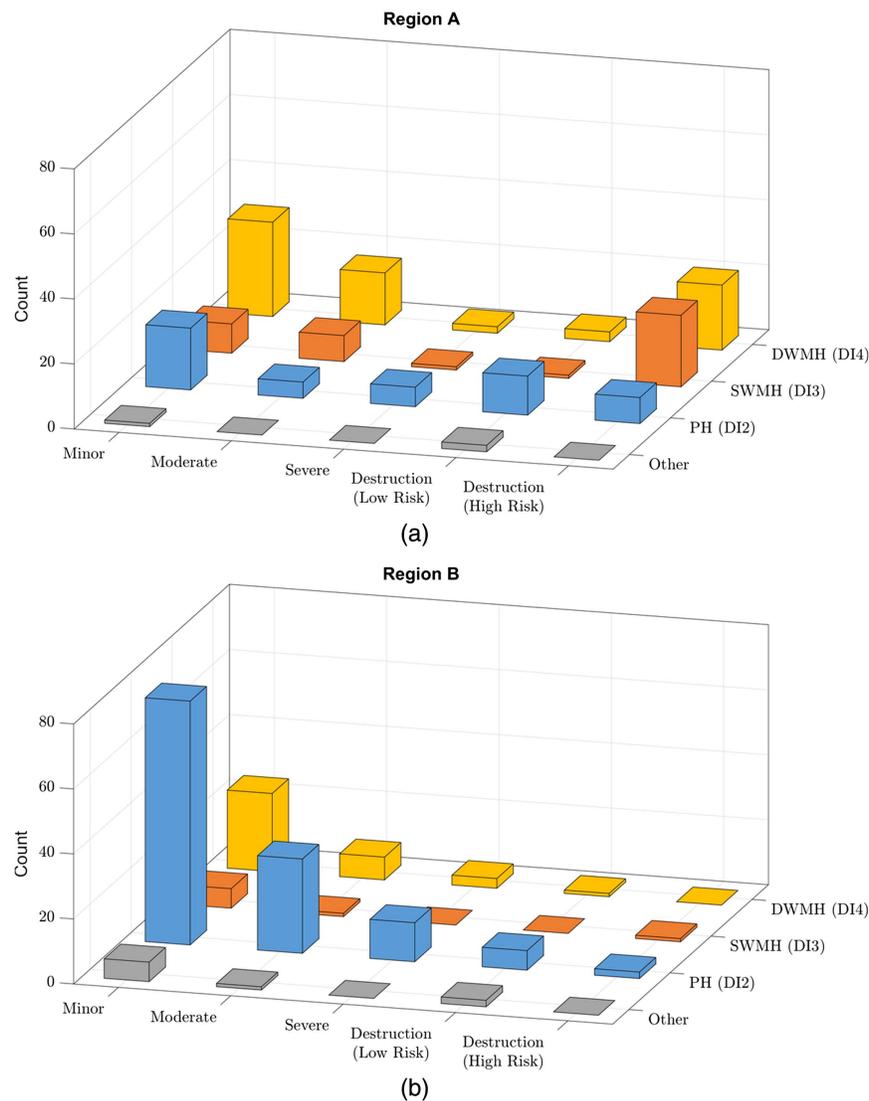
Fig. 6. Wind damage states of the affected buildings in (a) Region A; and (b) Region B using Vickery et al. (2006) but modified to separate economic destruction from destruction posing a high risk to life safety.

A considerable trend in the MH failures was the overall lack of an optimum damage progression. While damage generally initiated with loss of roof cover and cladding elements, very rarely was the loss of roof sheathing or roof structure observed with the anchorage system intact. The four primary mechanisms of structural failures observed in MHs consisted of the following: (1) separation at the marriage line (DWMHs only), (2) roof-to-wall connections, (3) wall-to-floor connections, and (4) failure of the anchorage system, resulting in either sliding, overturning, or lofting (Fig. 8). Of these potential mechanisms, the anchorage system was nearly universally the first element of the structural load path to fail during the tornado, compromising the entire structure and the safety of the occupants. This lack of safe failures in both SWMHs and DWMHs relative to PHs is exemplified in Fig. 6. Specifically, 12 of the 20
